ATM ENTERPRISES PTY LTD

AS2294.3 – 1997 [ISO3449:2008]
Australian Standard – Earthmoving machinery – Protective structures
Part 3: Laboratory tests and performance requirements for falling-object protective structures
Appendix A

Standard FOPS Test Report

Type	Hydraulic Excavator
Manufacturer	Komatsu
Models	PC650-3
Serial number/s	10757
Machine frame part number	N/A

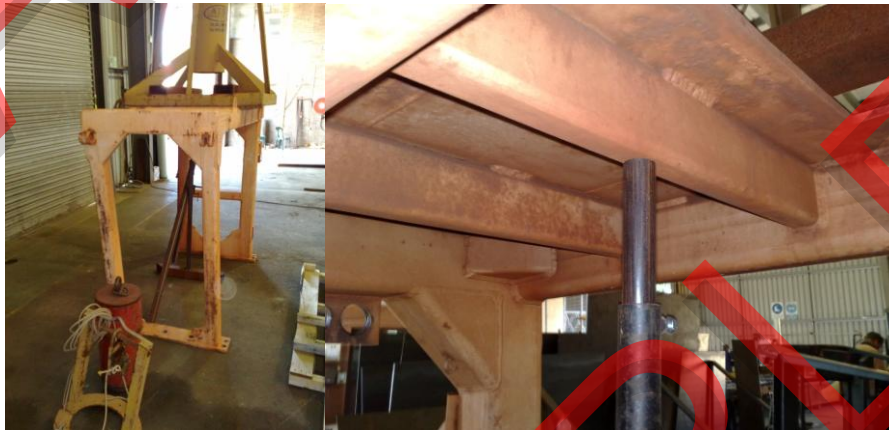
B.2.1 One photograph of drop test object and test arrangement before application of drop test/s

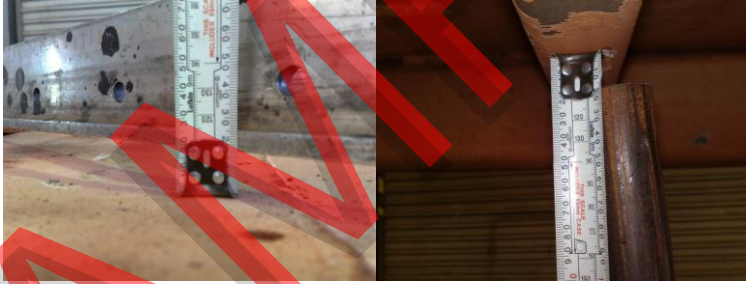
- B.2.2 Photographs as necessary to show top and bottom of FOPS structure after application of drop test/s

Energy imparted to the drop test object without causing penetration to any part of the FOPS structure, into the DLV nor penetration of the FOPS by the drop test object **11,600J**
